Fish Trap Creek Salmon Habitat Evaluation

Reconnaissance and Recommendations
for Fishtrap Creek, Orcas Island, San
Juan County, Washington.

Draft Final Report

November 23, 2004

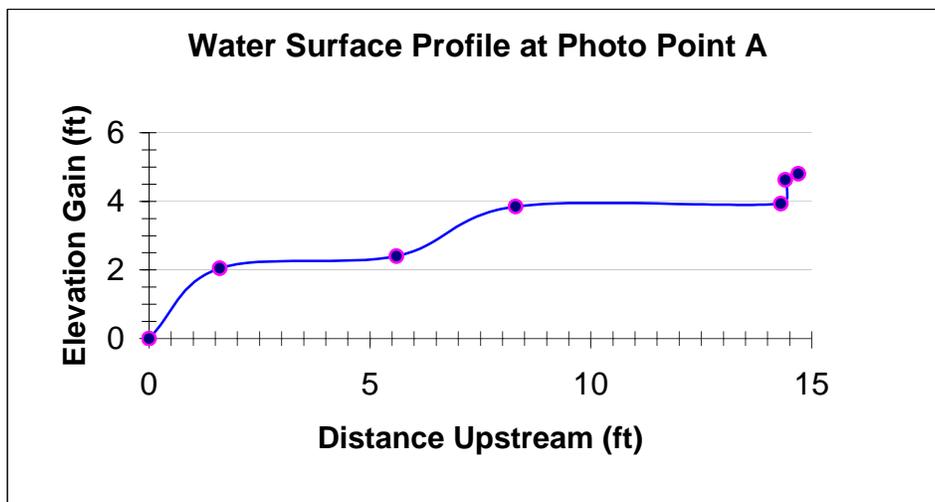
The channel from the mouth to a point approximately 60 meters upstream is deeply incised in a resistant clay hardpan that has headcut to create a potential fish migration barrier at approximately the 60 meter mark (Figure 1; Appendix A, Photo Point A). A V-notch plank weir immediately upstream from the headcut, installed by project partners to evaluate the watershed's hydrograph, further exasperates fish passage by increasing the overall drop to the channel below. The drop from the water surface upstream of the weir to the water surface in the channel below the clay plunge (located at the upstream end of the headcut) was 4.8 ft over a distance of 14.7 ft. Thus, the gradient for this short stream segment is 32.6%. The drop from the water surface just below the weir to the water surface below the clay plunge is 3.93 ft. Part of the distance from the weir to the final vertical plunge of 2.05 ft at the clay drop off is a short steep cascade. Water depth at the base of the clay plunge was 0.29 ft. The complete lack of plunge pool depth makes upstream fish migration very unlikely, except possibly during extremely high tides.

Figure 1: Water surface measurements at Photo Point A. The increase in water surface elevations is caused by headcutting and a plank weir located 60 m upstream of the mouth on Fishtrap Creek. The impediment extends for 14.7 ft upstream. Total elevation rise is 4.8 ft, resulting in a 32.6% gradient.

- Increase habitat complexity in the lower 300 meters of the stream by naturalizing the stream channel - adding meanders and large wood and possibly rock to provide both cover and aid in pool formation. Design should be based on historical information for that reach of Fishtrap Creek, or based on an appropriately similar analog watershed. Design should address headcut located 60m upstream from the stream mouth.

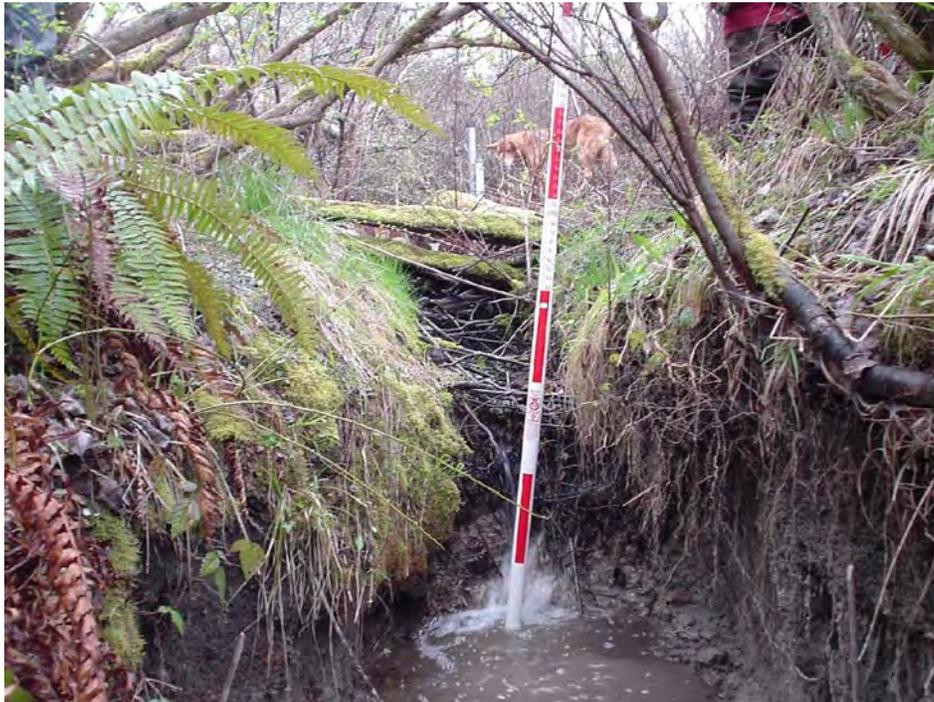
PHOTO POINT A

- (k) a bedrock chute on Treacy's Tributary (Photo Pt R)
- The weir and vertical drop located approximately 60 m upstream of the mouth is a significant impediment and may be a complete barrier to fish migration: overall drop of 4.8 ft with a final plunge of 2.05ft. This needs to be observed at high tide and high flows to make a barrier status determination (Appendix A, Photo Point A).

Map ID	Culvert ID	Sequencer	Passage Status (WDFW)	Passage Status (WT)	Photo #s	Survey Date
A	N/A	N/A	N/A	Impediment	1, 2	3/24/04
Shape	Material	Coating	Span	Rise	Length	Bed Material
N/A	N/A	N/A	N/A	N/A	N/A	N/A
Outfall Drop	Culvert Slope	Water Depth	Velocity	Slope Break	Toe	Culv/Toe Ratio
N/A	N/A	N/A	N/A	N/A	N/A	N/A
Comments:						
<p>This is an impediment attributable to a vertical drop of 2.05 ft caused by headcutting in resistant glacial hardpan, further exasperated by a V-notched plank weir (0.7ft drop) upstream of the headcut. A short cascade exists between the weir and the final drop: total distance of 14.7 ft with a total drop of 4.8ft for a slope of 32.6%. No plunge pool at the bottom of the final drop and shallow water makes this an extremely difficult obstacle for upstream fish passage. Extremely high tides may ease fish passage.</p>

Photo Point A - Photo 1: Headcut channel and clay plunge located at the base of the V-notched weir.

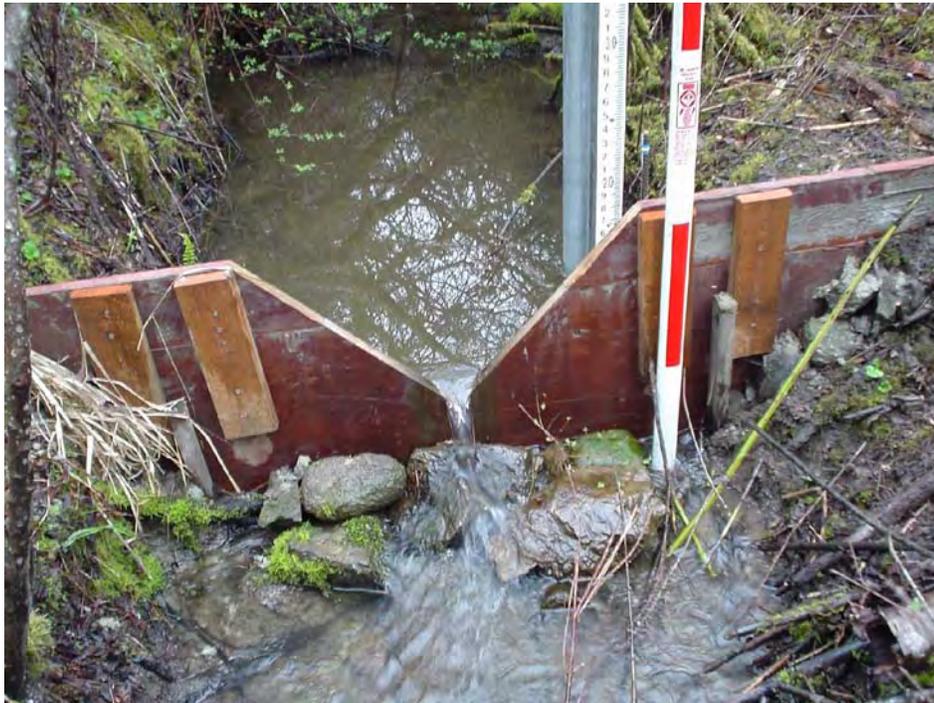
Photo Point A - Photo 2: V-notched plank weir immediately upstream of the headcut in Photo 1. The weir, installed by project partners to evaluate the watershed's hydrograph, exasperates fish passage by increasing the overall drop to the channel below.

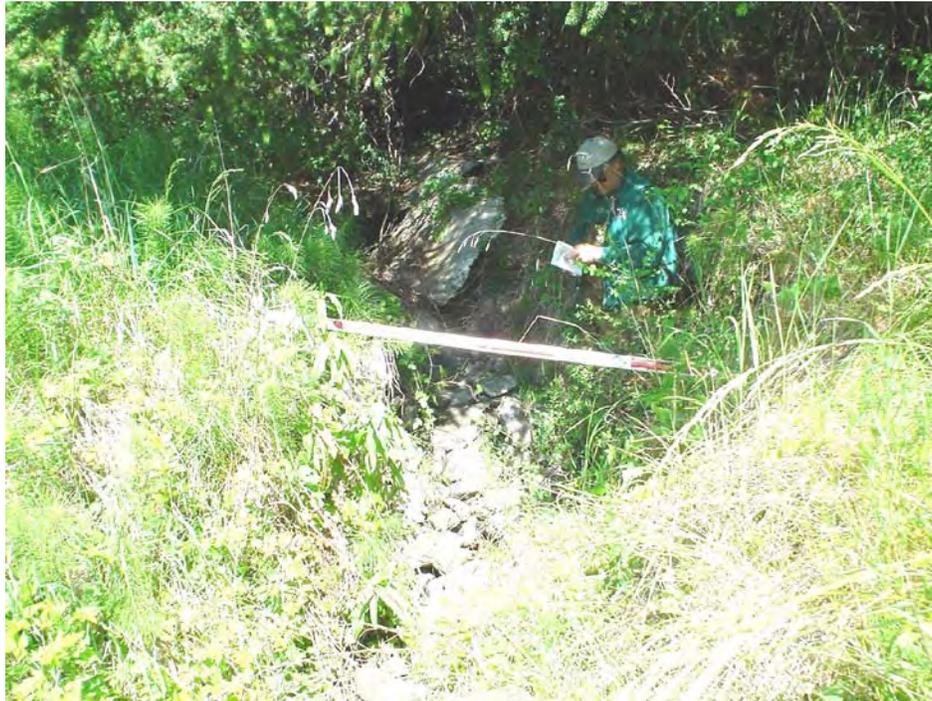
PHOTO POINT B

Pond depth was not measured. The pond's outlet structure is an anthropogenic barrier to fish migration. The spillway at the pond culvert outlet is undermined and water is percolating through the dam and under the spillway. The spillway is broken in the middle, and there is a 2 ft vertical drop to the 2nd half of the spillway. The bottom of the spillway drops 2 ft to the stream channel. The stream channel downstream of the spillway is diked and armored with riprap for approximately 10 m (30 ft) at >20% gradient (Appendix A, Photo Point B). The water temperature of the pond was 21.0° C on 5/18/04. Anecdotal reports suggest the pond had been stocked with trout in the past. While no fish were observed in the pond during the survey, fyke netting or another method of sampling would be necessary to confirm fish absence. There was very little water flowing downstream of the pond dam and spillway.

Map ID	Culvert ID	Sequencer	Passage Status (WDFW)	Passage Status (WT)	Photo #'s	Survey Date
B	N/A	1.1	Barrier	Barrier	3, 4	5/18/2004
Location		Shape	Material	Span (ft)	Rise (ft)	Length
Pond Outlet (@ 450 m)		RND	CST	1.5	1.5	N/A
Culvert Slope	Slope Break	Bed Material	Culvert Water Depth	Velocity	Outfall Drop	Plunge Pool Max. Depth
N/A	N/A	N/A	N/A	N/A	N/A	N/A
Plunge Pool Length x Width	Toe (ft)	Culv/Toe Ratio	Fill Depth (ft)	Ownership	Problem	
N/A	N/A	N/A	-8-9	Private	Outfall Drop	
Comments:						
Broken concrete spillway on pond culvert outlet: 2ft drop from existing spillway to broken spillway section then a 2ft drop from the broken section to a rip rapped channel.

Photo Point B - Photo 3: Broken concrete spillway with 2 ft vertical drops between broken spillway slabs. The channel downstream of the spillway is completely rip rapped with a 20% gradient.

- Replace the outlet of the pond downstream of Cormorant Bay Road at 450 m with a fishway allowing fish passage into and above the pond.
 - Replace the Cormorant Bay Road culvert with one that meets WDFW fish passage criteria.
-

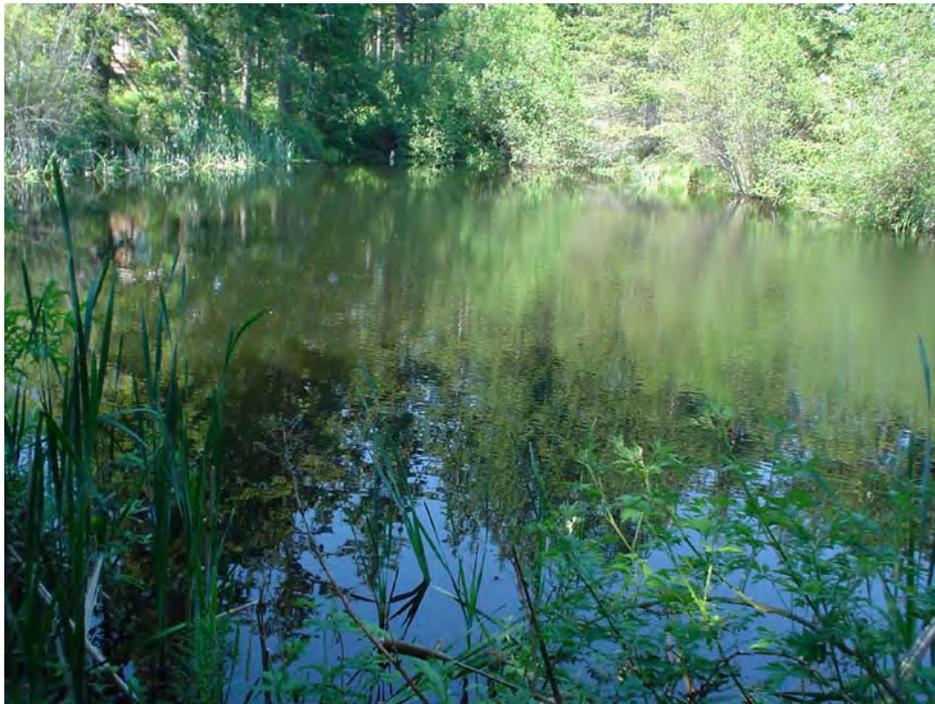
Photo Point B - Photo 4: Pond associated with Photo #3 culvert and spillway. This pond is located approximately 450 m upstream of the mouth and approximately 50 m downstream of Cormorant Bay Road.

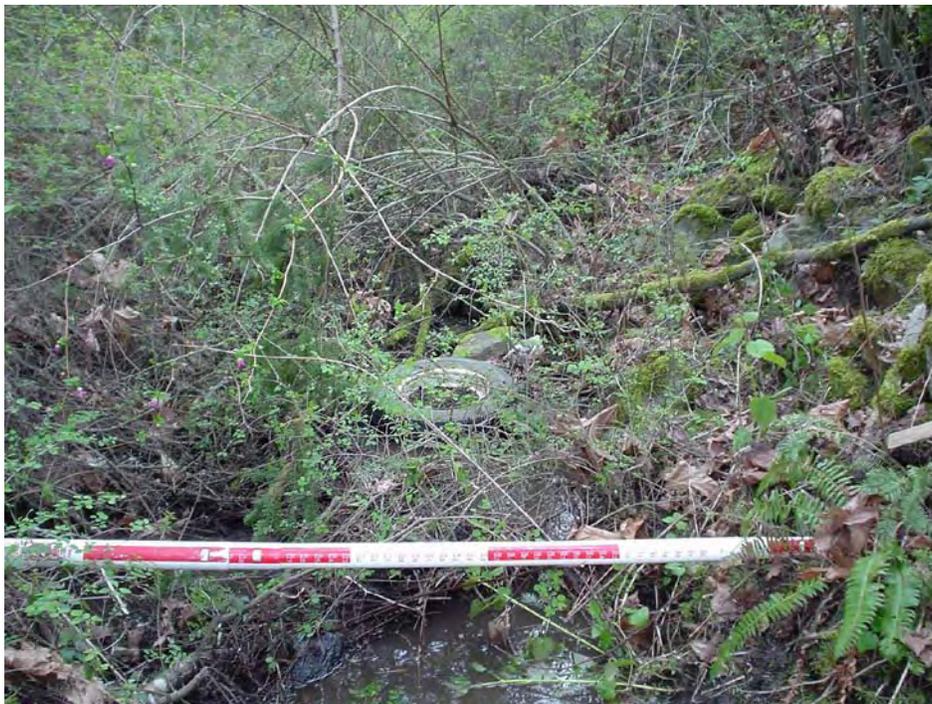
PHOTO POINT C

Map ID	Culvert ID	Sequencer	Passage Status (WDFW)	Passage Status (WT)	Photo #'s	Survey Date
C	FISH-01	1.1	Barrier	67% Passage	4,5,6,7	3/23/04
Location		Shape	Material	Span/Dia (ft)	Rise (ft)	Length (ft.)
Cormorant Bay Road (~550 m)		RND	PCC/CAL	1.5	1.5	45.21
Culvert Slope (%)	Slope Break	Bed Material	Water Depth (ft)	Velocity (ft3/sec)	Outfall Drop	Plunge Pool Max. Depth

4.91	No	No	0.65	~1.0	No	N/A
Plunge Pool Length x Width	Toe (ft)	Culv. / Toe Ratio (%)	Fill Depth (ft)	Ownership	Problem	
N/A	4.7	31.9	8.7	County	Slope and Culv./Toe ratio	
<p>A pool exists at the culvert outlet, however, this is not a plunge pool. Max pool depth is 0.65 ft. Pool dimensions are 6.3 ft long x 5.7 ft wide. Backwatering within this culvert helps passage at this time, nevertheless, velocities could prohibit passage during high flows due to the high 4.9% gradient. This culvert exceeds WDFW slope recommendations and does not meet the WDFW culvert to toe ratio recommendations.</p>

Photo Point C – Photo 5: Typical channel habitat immediately downstream of the Cormorant Bay Road culvert (Fish-01). Average bankfull width downstream equals 5.2 ft.

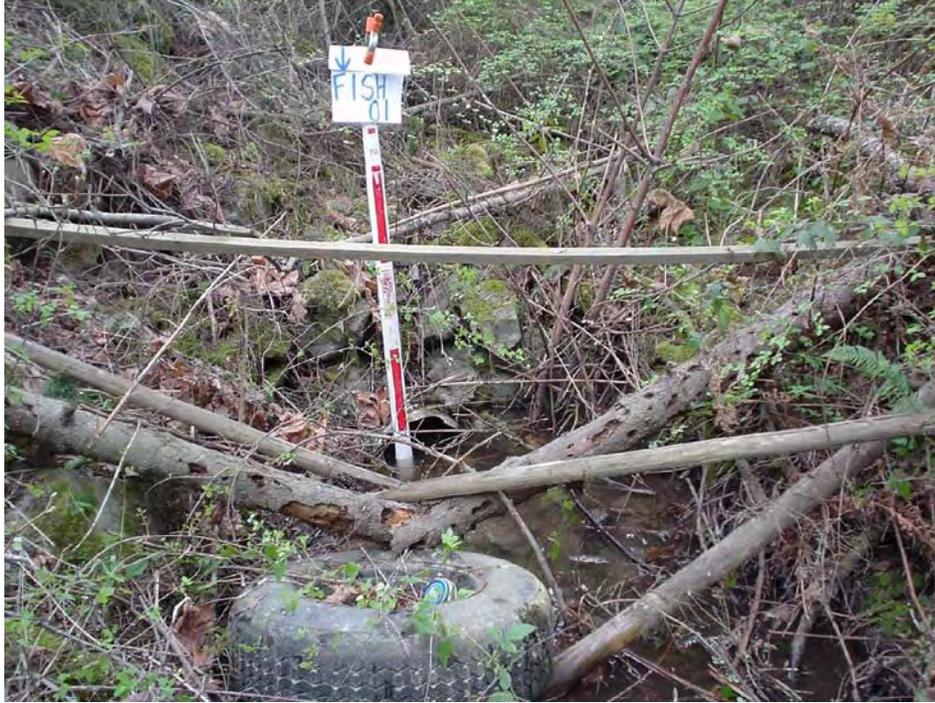
Photo Point C - Photo 6: Outlet of the Cormorant Bay Road Culvert (Fish-01).

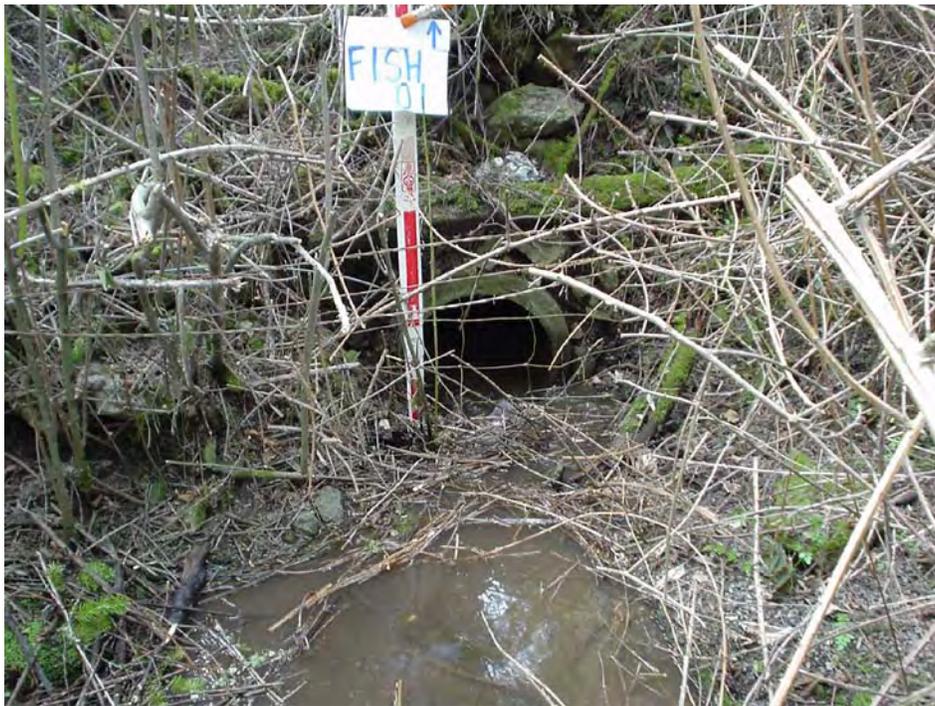
Photo Point C - Photo 7: Inlet of the Comorant Bay Road culvert.

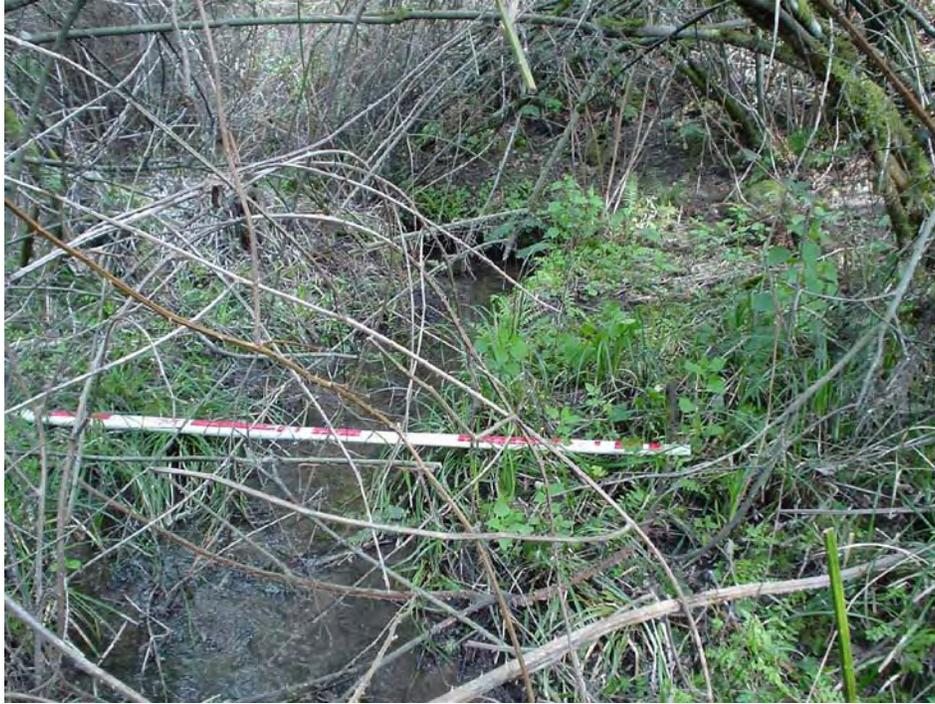
Photo Point C - Photo 8: Typical channel habitat upstream of the Comorant Bay Road culvert. Average bankfull width equals 2.9 ft.

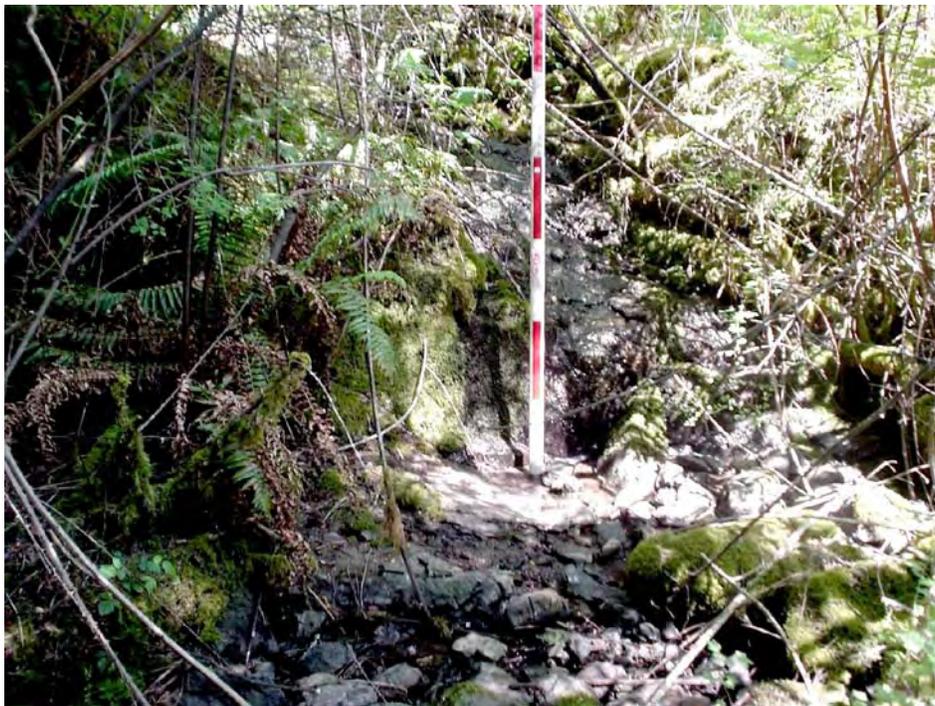
PHOTO POINT D

Map ID	Culvert ID	Sequencer	Passage Status (WDFW)	Passage Status (WT)	Photo #'s	Survey Date
D	N/A	N/A	N/A	Impediment	9	5/18/2004
Location		Shape	Material	Span/Dia (ft)	Rise (ft)	Length (ft.)
~STA. 650 m		N/A	N/A	N/A	N/A	10
Culvert Slope (%)	Slope Break	Bed Material	Water Depth (ft)	Velocity (ft3/sec)	Outfall Drop	Plunge Pool Max. Depth (ft)
N/A	N/A	N/A	N/A	N/A	N/A	0.52
Plunge Pool Length x Width	Toe (ft)	Culv. / Toe Ratio (%)	Fill Depth (ft)	Ownership	Problem	
4.0 x 2.7	N/A	N/A	N/A	N/A	Cascade/Waterfall - slope	
Comments:						
This is a cascading waterfall with a 50% slope (total drop of 5 ft over 10 ft distance). The cascade has a final drop of 2.4 ft into a plunge pool which is 0.52 ft in depth.

Photo Point D - Photo 9: A bedrock waterfall and cascade which drops 5ft over a linear distance of 10ft.

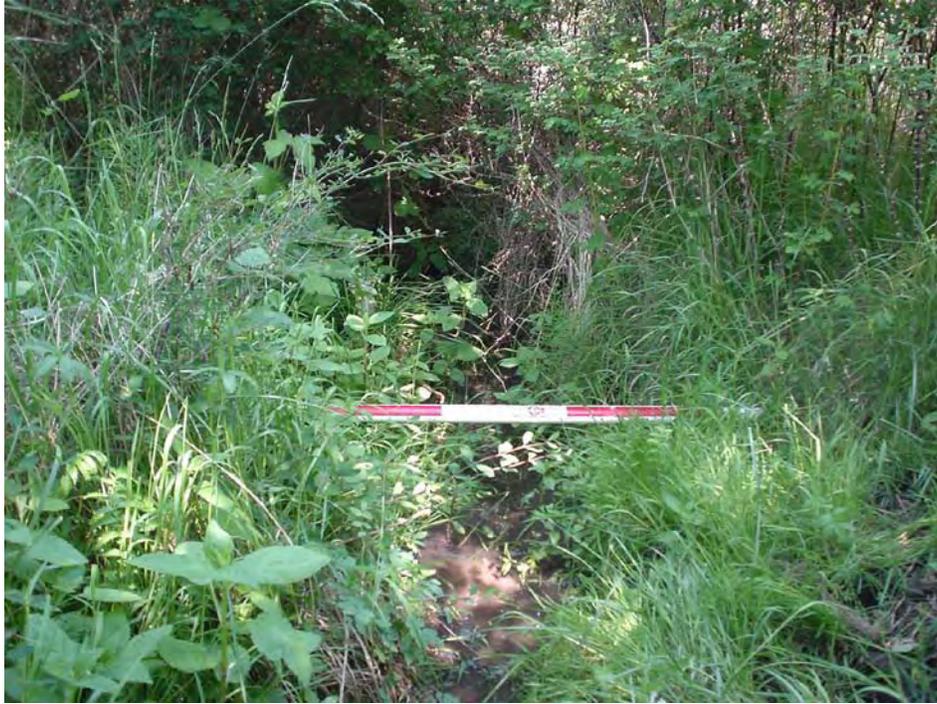
PHOTO POINT E

Photo Point E - Photo 10: Ditched channel between 900 m and 1,000 m.

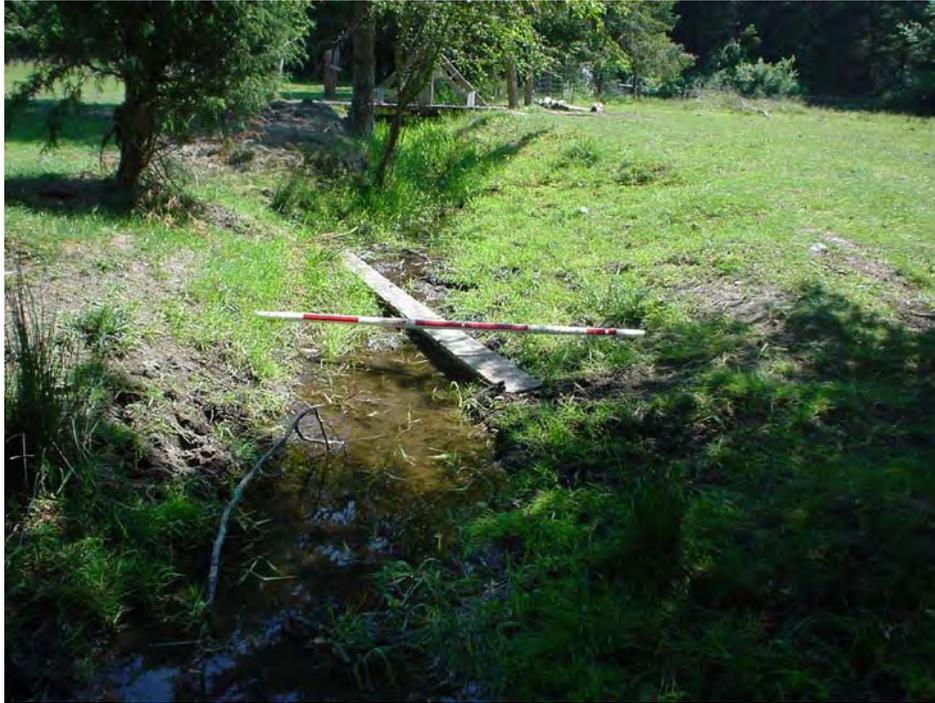
PHOTO POINT F

Photo Point F - Photo 11: Ditched section of Fishtrap Creek accessible to livestock.

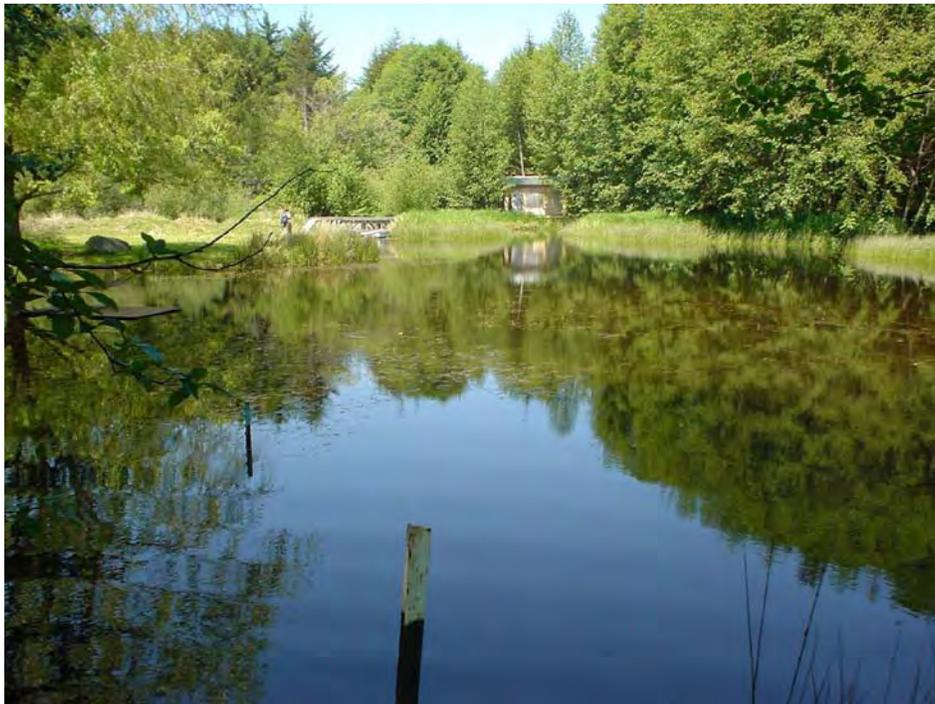
Photo Point F - Photo 12: Private pond located approximately 1250 m upstream of the mouth and immediately upstream of the ditched channel in Photo 11.

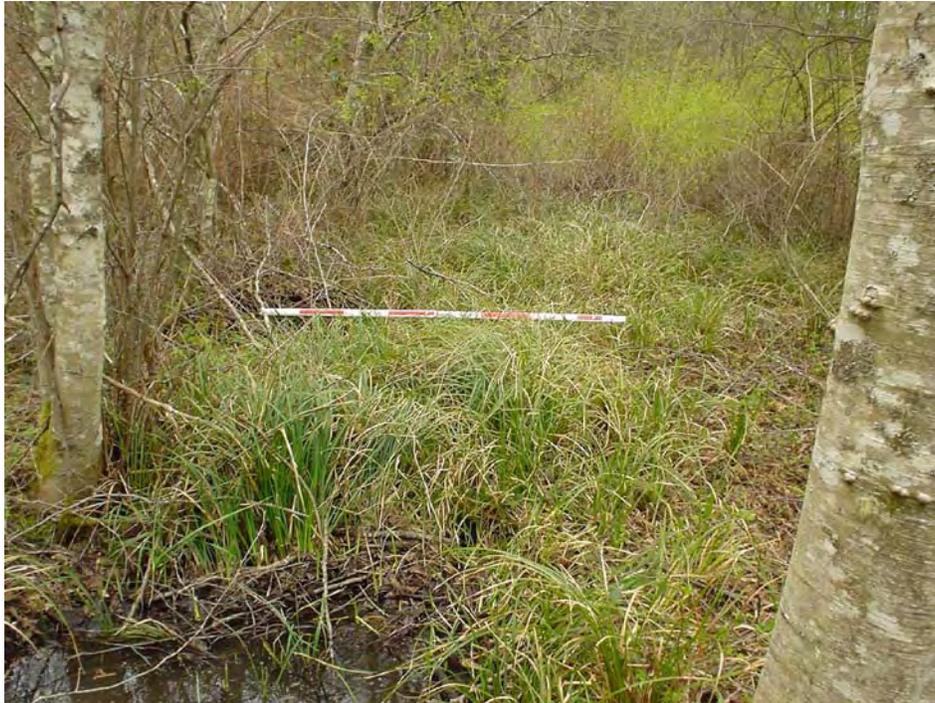
Photo Point G - Photo 13: Typical channel habitat downstream of the Fish-02 culverts.

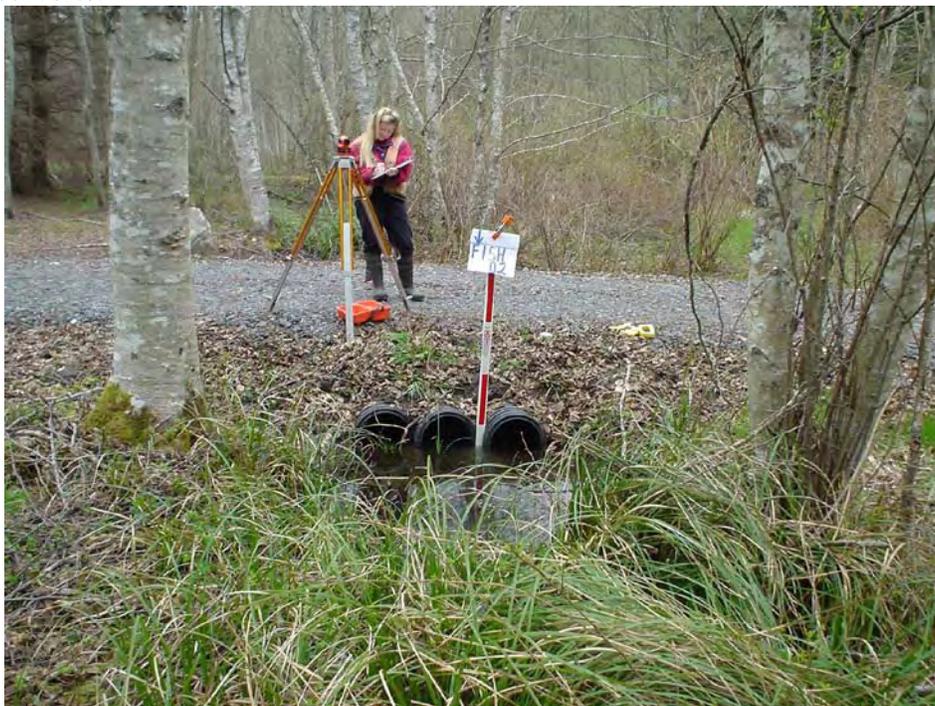
- Lack of water and flow in the upper segments of Reach C inhibits fish use.
- The (Fish-02) culverts appear by Washington Trout Crews to be 100% passable, however, because these culverts do not have substrate throughout and because the maximum water depth does not meet WDFW recommended standards for salmonids, these culverts could not be unequivocally designated as ‘barrier’ or ‘non-barrier’ using the WDFW protocol. Consequently, barrier status was recorded as ‘unknown’ and further analysis is needed to determine passage status (Appendix A, Photo Point G). A level B survey has been conducted on this culvert, however, level B analysis was not part of this survey. Level B culvert information is available upon request.

0.1	No	No	0.42	Stagnant	No	0.43
Plunge Pool Length x Width	Toe (ft)	Culv. / Toe Ratio (%)	Fill Depth (ft)	Ownership	Problem	
6.5 x 6.3	3.5	85.71*	0.92	Private	No material throughout culvert.	
Comments:						
This culvert is located on the right bank and is the third of three adjoining culverts at this site. WDFW barrier status is unknown according to protocol. WT crews believe this culvert is 100% passable, but velocity and water depth should be measured during high flows to confirm this. Velocity at the time of the survey was too slow to measure. * Culv./Toe Ratio (%) was based on the cumulative total span width of the three culverts. A level B survey is available upon request.

Photo Point G - Photo 14: Outlet of the Fish-02 culverts crossing a private drive located at 1410 m.

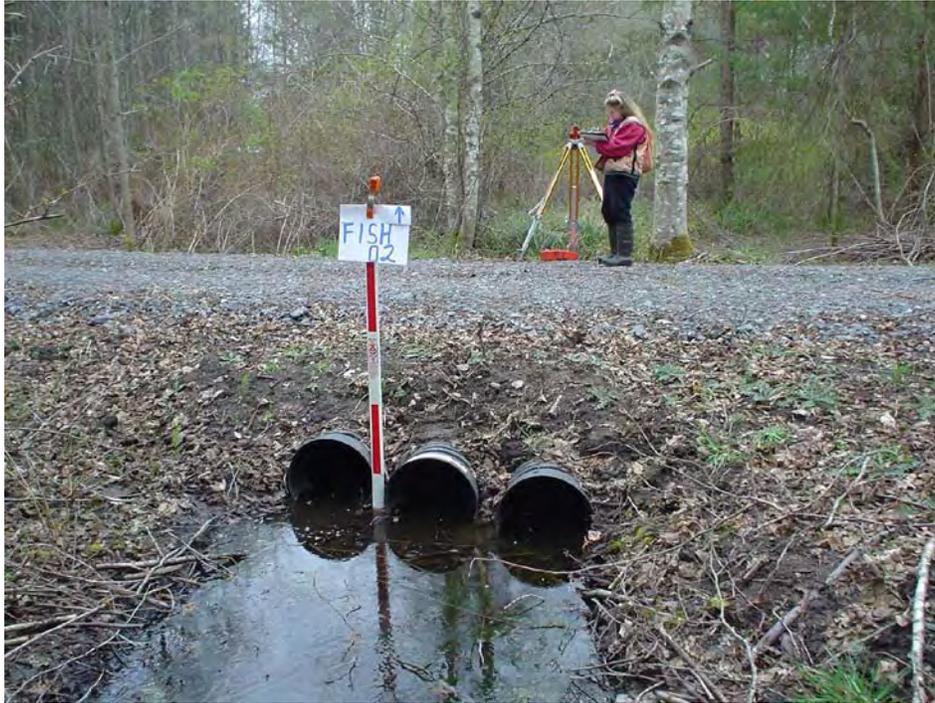
Photo Point G - Photo 15: Inlet of the Fish-02 culverts.

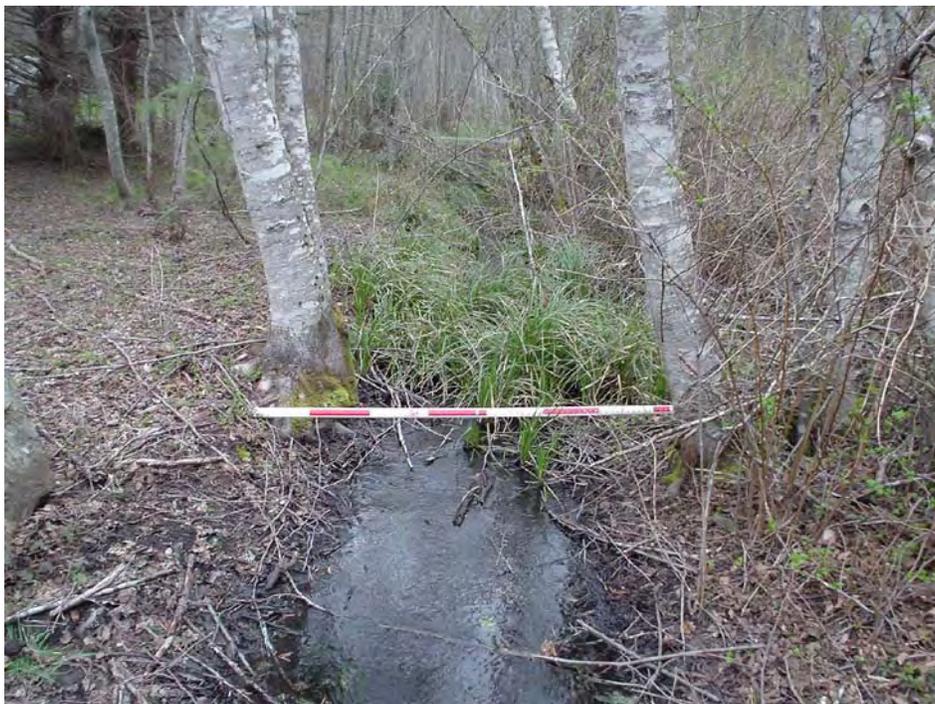
Photo Point G - Photo 16: Typical channel habitat upstream of the Fish-02 culvert inlets.

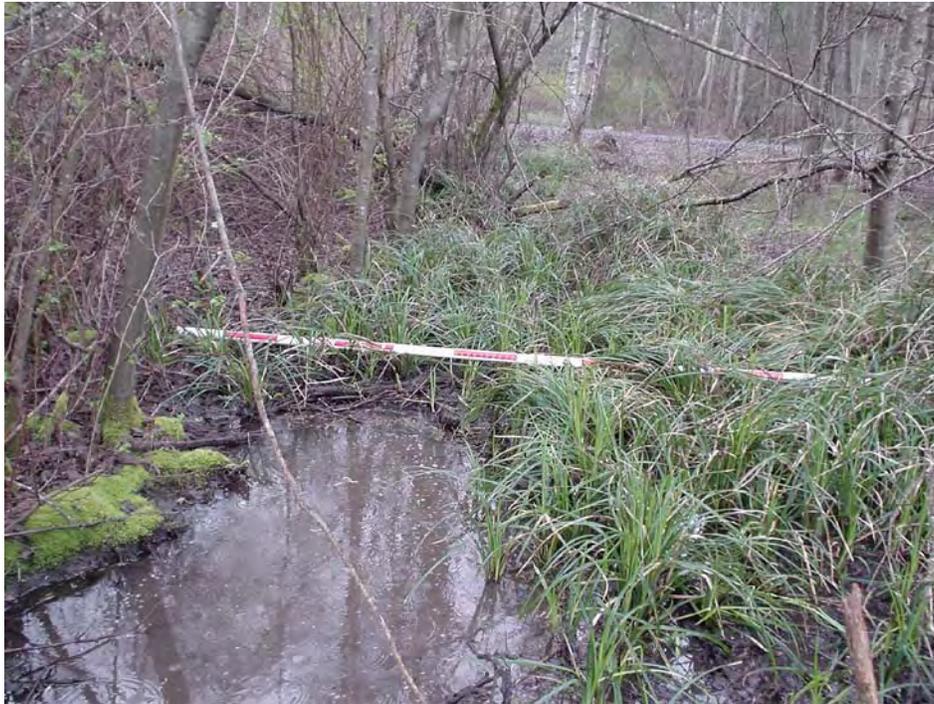
PHOTO POINT H

- The (Fish-03) culvert appears by Washington Trout Crews to be 33% passable at the time of the survey. Water depth appears to be problematic, prohibiting some fish from passing the culvert. Because the culvert/toe ratio does not meet WDFW recommended standards this culvert could not be unequivocally designated as ‘barrier’ or ‘non-barrier’ using the WDFW protocol. Consequently, barrier status was recorded as ‘unknown’ and further analysis is needed to determine passage status (Appendix A, Photo Point H). A level B survey has been conducted on this culvert, however, level B analysis was not part of this survey. Level B culvert information is available upon request.

Map ID	Culvert ID	Sequencer	Passage Status (WDFW)	Passage Status (WT)	Photo #'s	Survey Date
H	FISH-03	1.1	UNK	33% Passable		3/23/2004
Location		Shape	Material	Span/Dia (ft)	Rise (ft)	Length (ft.)
Penny Lane		RND	Smooth - ABS	2.0 DS / 1.5 US*	2.0 / 1.5	20
Culvert Slope (%)	Slope Break	Bed Material	Water Depth (ft)	Velocity (ft3/sec)	Outfall Drop	Plunge Pool Max. Depth (ft)
-0.3	No	Yes	0.2	0.98	No	N/A
Plunge Pool Length x Width	Toe (ft)	Culv. / Toe Ratio (%)	Fill Depth (ft)	Ownership	Problem	
N/A	3.6	41.67	1.29	Private	Culv./Toe Ratio; Water depth	
Comments:						
WDFW barrier status is unknown according to protocol. WT crews believe this culvert is currently 33% passable; depth appears problematic and the culvert may be undersized, further analysis is needed during higher flows.* The culvert has a 2.0 ft diameter at the outlet and a 1.5 ft diameter at the inlet. The outlet pool has a max. depth of 0.66 ft (this is not a plunge pool).

Photo Point H - Photo 17: Typical channel downstream of the Penny Lane culvert (Fish-03).

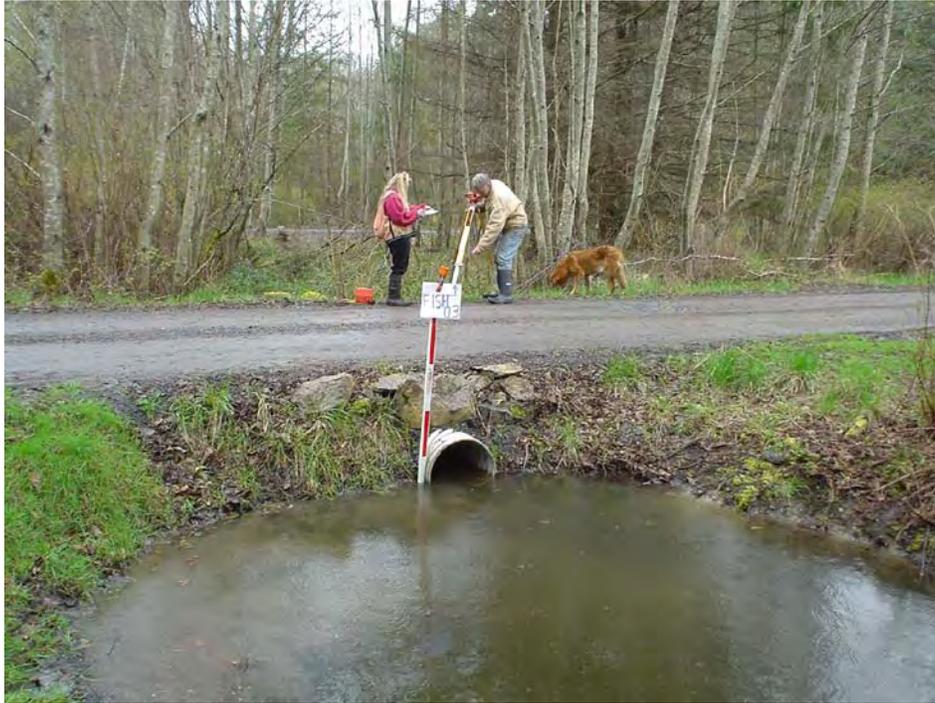
Photo Point H-Photo 18: Outlet of Fish-03 culvert.

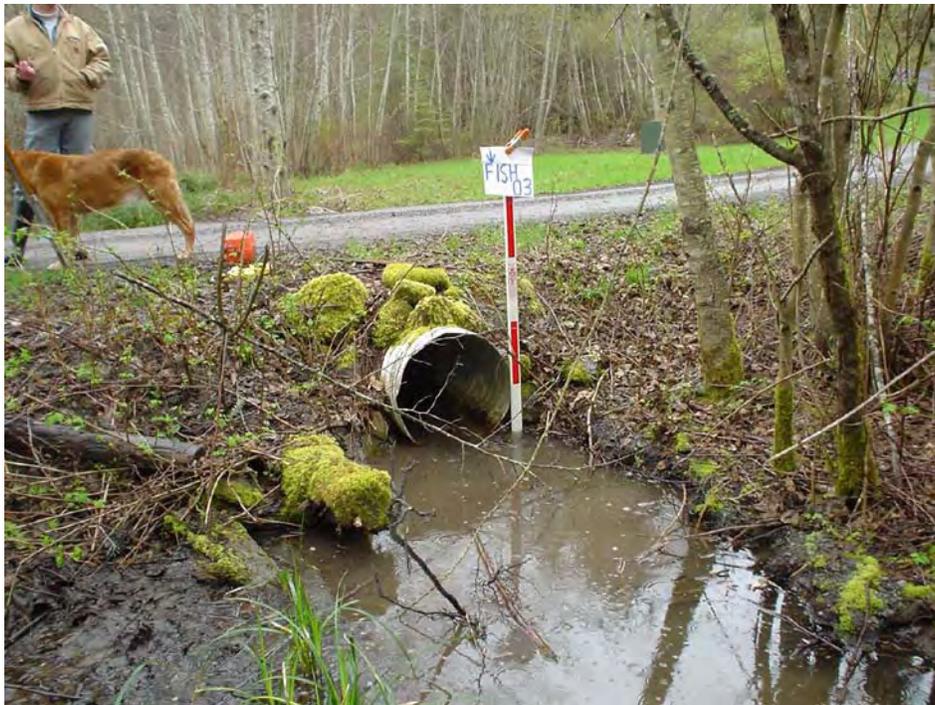
Photo Point H - Photo 19: Inlet of Penny Lane culvert (Fish-03).

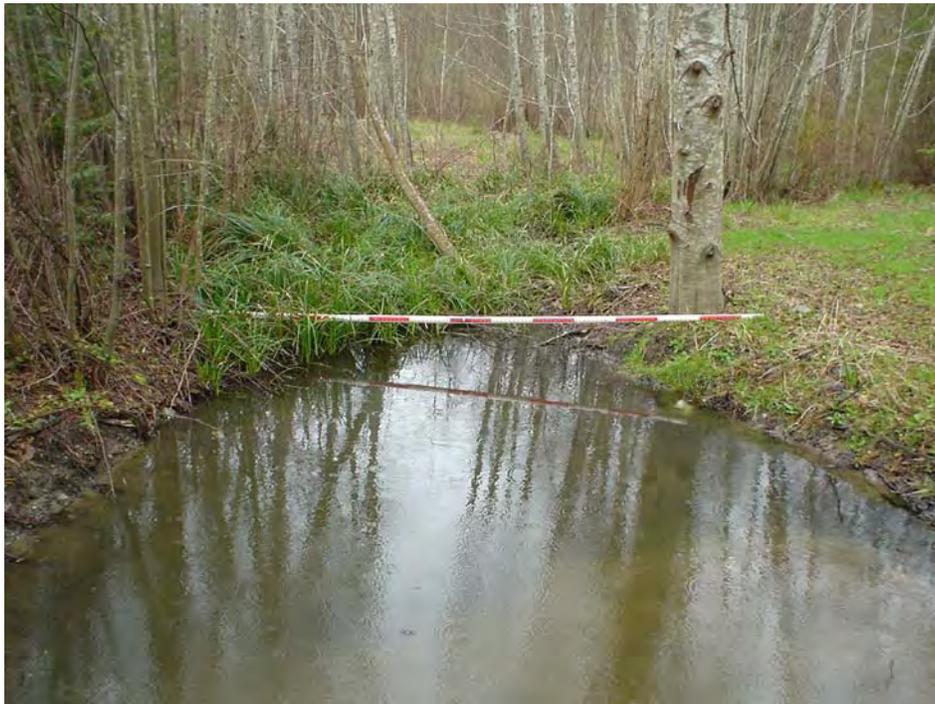
Photo Point H - Photo 20: Looking upstream from inlet of Penny Lane culvert (Fish-03).

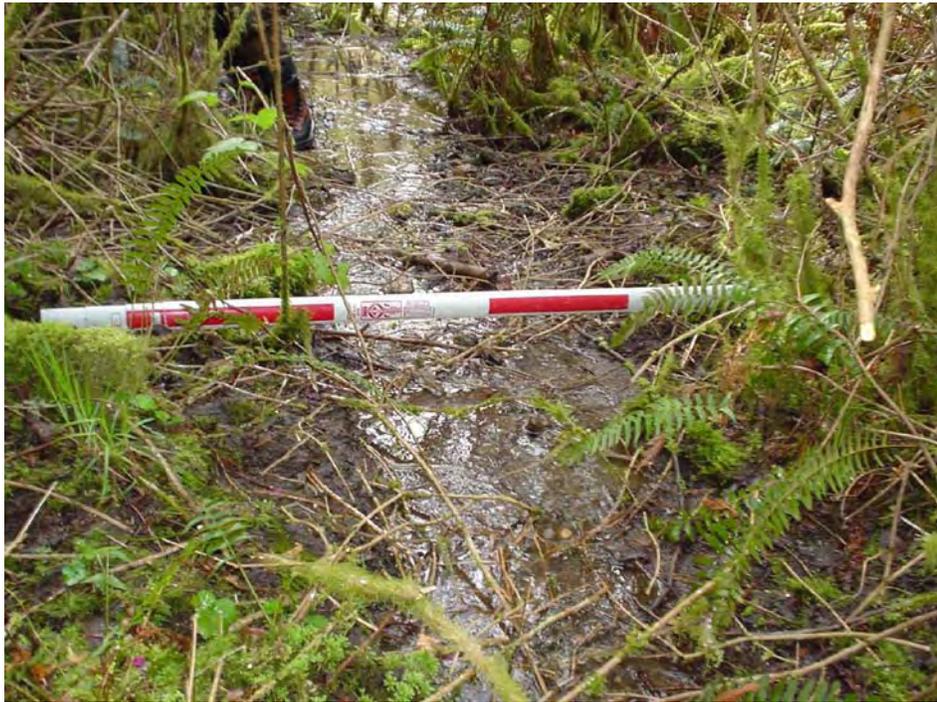
PHOTO POINT K

Photo Point K - Photo 24: Best potential spawning gravels observed in Fishtrap.

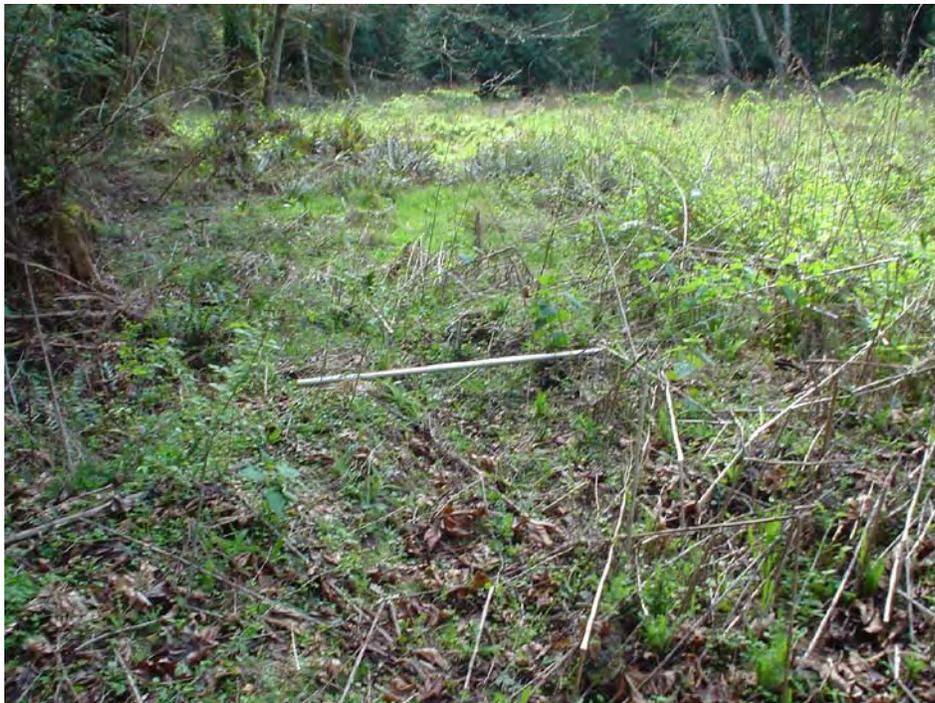
Photo Point L - Photo 26: Dry channel upstream of test pit.

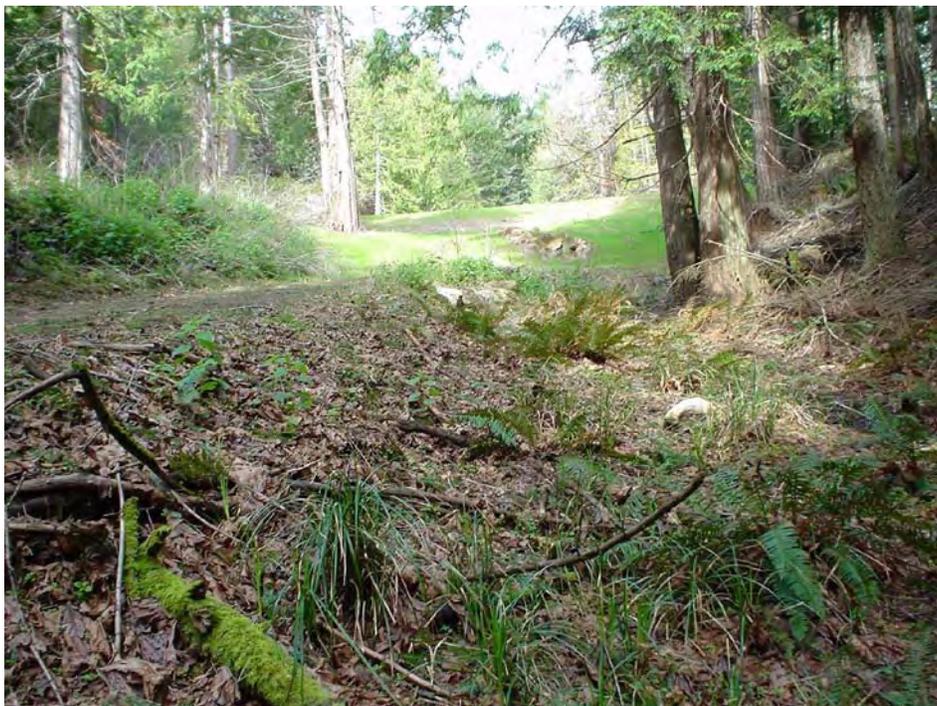
Photo Point M - Photo 27: Looking upstream at the dry stream channel below Helso's Pond.

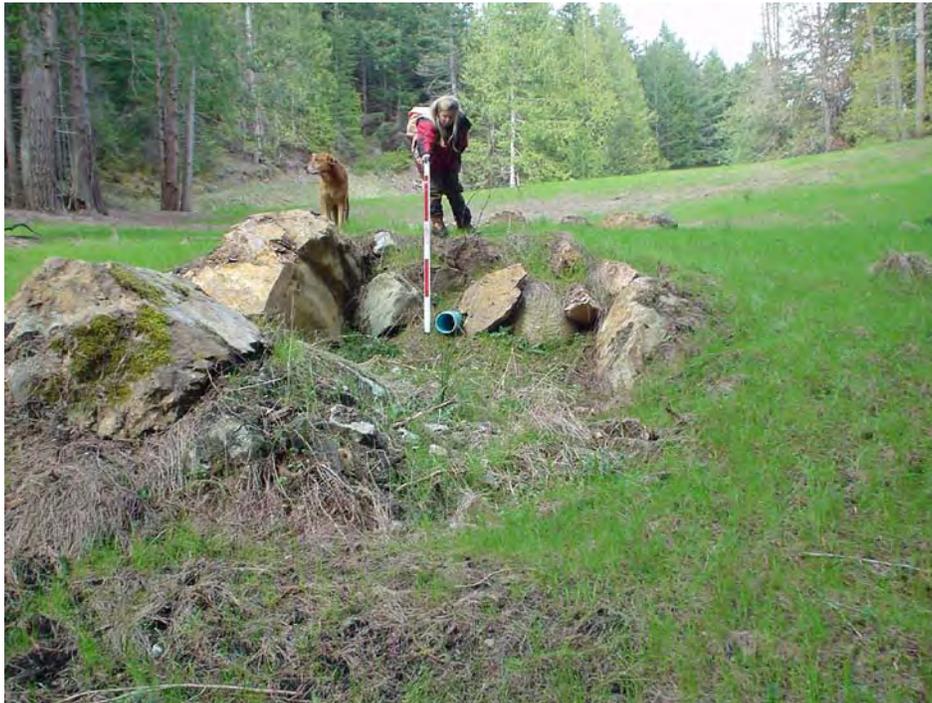
PHOTO POINT N

- The disconnection between Helso’s pond at the headwaters and the stream does not provide for fish passage. The earthen dam may also be at risk for failure during earthquakes or storm events. It currently leaks an estimated 2 gallons a minute according to the landowner (Appendix A, Photo Point N).

Map ID	Culvert ID	Sequencer	Passage Status (WDFW)	Passage Status (WT)	Photo #'s	Survey Date
N	FISH-05	1.1	UNK	100% Barrier	29, 30-33	3/23/2004
Location		Shape	Material	Span/Dia (ft)	Rise (ft)	Length (ft.)
Helso's Pond Outlet		RND	Smooth - ABS	0.5	0.5	UNK
Culvert Slope (%)	Slope Break	Bed Material	Water Depth (ft)	Velocity (ft3/sec)	Outfall Drop	Plunge Pool Max. Depth (ft)
UNK	UNK	No	No	N/A	0.75	N/A
Plunge Pool Length x Width	Toe (ft)	Culv. / Toe Ratio (%)	Fill Depth (ft)	Ownership	Problem	
N/A	UNK	UNK	~12.31	Private	No fish passage provided.	
Comments:						
<p>This is a 0.5 ft pipe extending from the pond through the pond dam. The pipe has a valve which was closed during our survey preventing water from flowing from Helso's pond into Fishttrap Creek. When water in the pond rises, overflow is directed through the overflow culvert at the North end of the lake (photo point O). As a result, pond overflow is forced into the Skull Creek watershed rather than flowing into Fishttrap Creek.</p>

Photo Point N - Photo 29: Looking upstream at Fish-05 pipe at Helso's Pond.

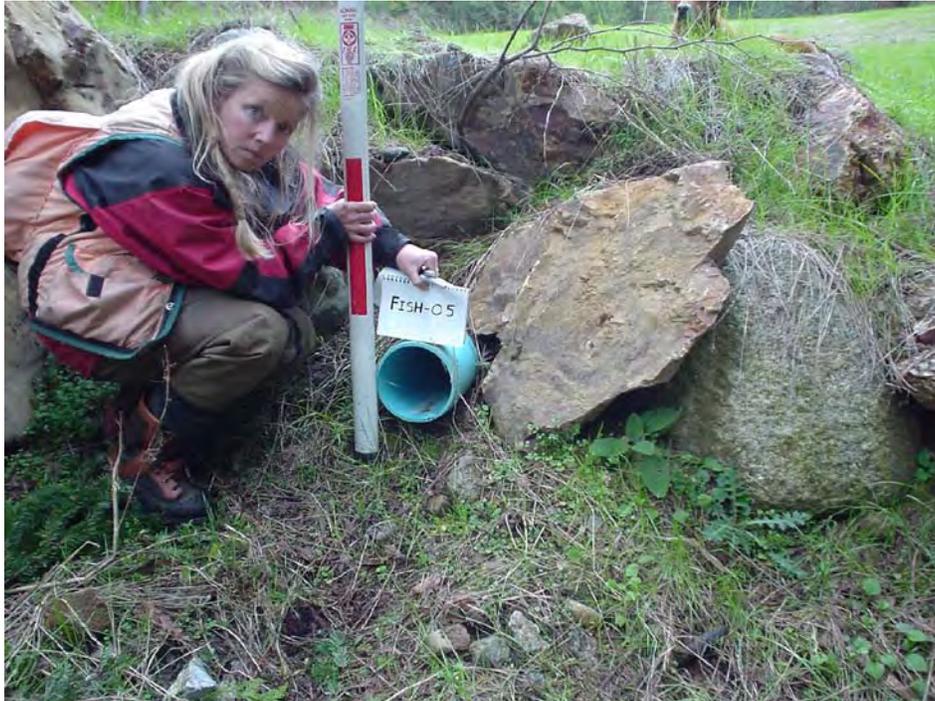
Photo Point N - Photo 30: Outlet of the Fish-05 pipe; a closed valve on this pipe prevents lake flow from entering Fishtrap Creek.

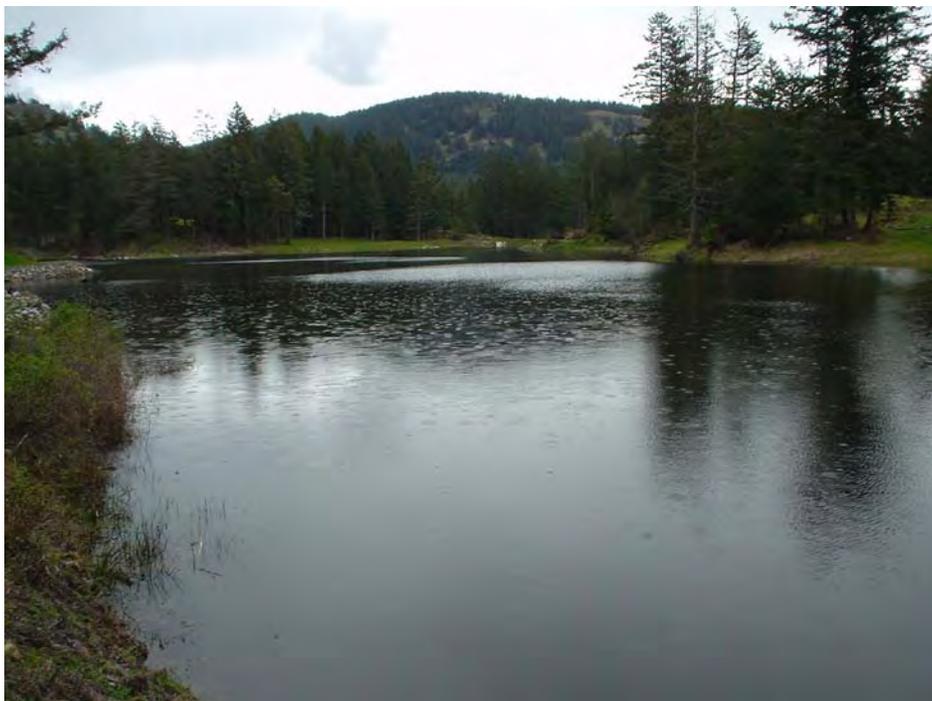
Photo Point N - Photo 34: Looking across Helso's Lake at Fish-05 overflow culvert (white dot in center of photo) which drains into Skull Creek watershed.

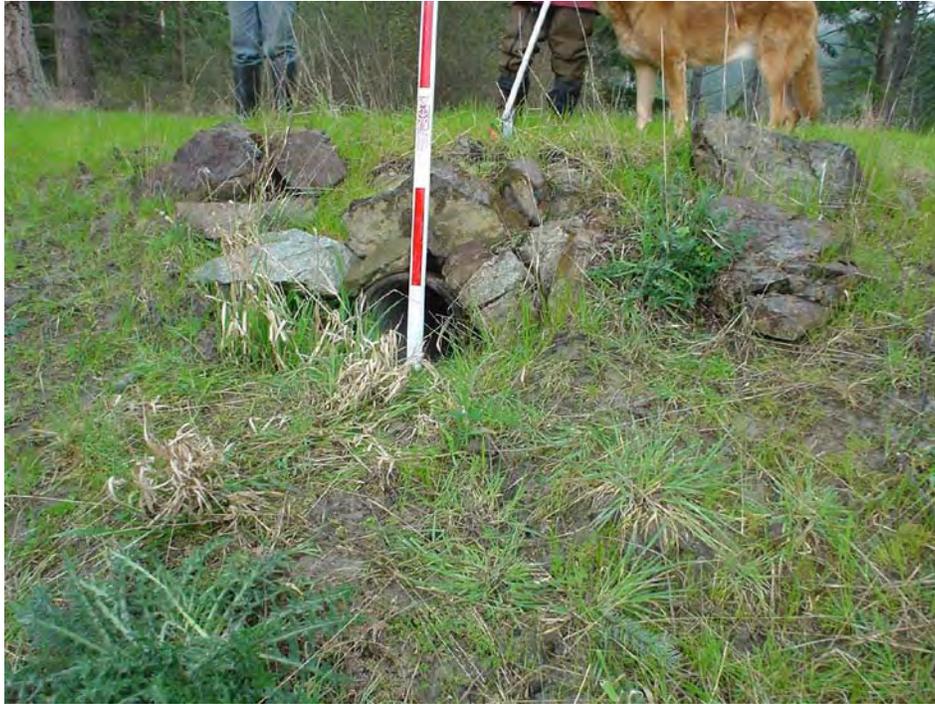
PHOTO POINT 0

Map ID	Culvert ID	Sequencer	Passage Status (WDFW)	Passage Status (WT)	Photo #'s	Survey Date
0	N/A	1.1	UNK	100% Barrier	35	3/23/2004
Location		Shape	Material	Span/Dia (ft)	Rise (ft)	Length (ft.)
Helso's Pond Outlet		RND	SST	1.05	1.05	UNK
Culvert Slope (%)	Slope Break	Bed Material	Water Depth (ft)	Velocity (ft3/sec)	Outfall Drop	Plunge Pool Max. Depth (ft)
UNK	UNK	No	No	N/A	UNK	N/A
Plunge Pool Length x Width	Toe (ft)	Culv. / Toe Ratio (%)	Fill Depth (ft)	Ownership	Problem	
N/A	Pond	UNK	UNK	Private	Unkown	
Comments:						
This culvert was not designed to pass fish.

Photo Point O – Photo 35: Outlet of the overflow culvert at Helso's Lake.
