Fish Trap Creek Salmon Habitat Evaluation

Reconnaissance and Recommendations
for Fishtrap Creek, Orcas Island, San
Juan County, Washington.

Draft Final Report

November 23, 2004

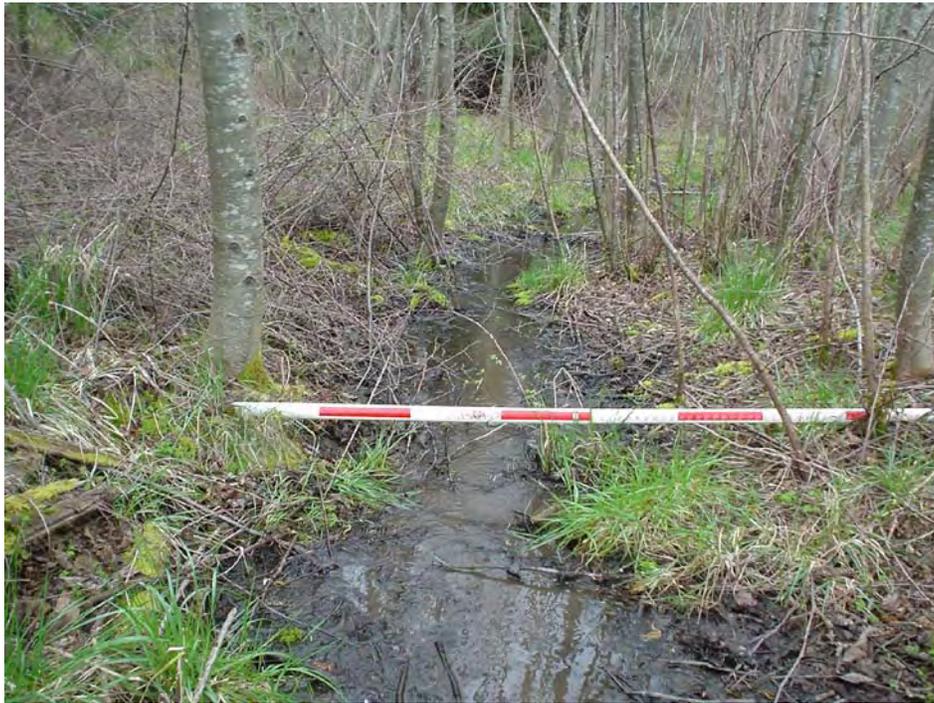
PHOTO POINT P

- The (Fish-04) culvert appears by Washington Trout Crews to be 33% passable, however, because the culvert/toe ratio and water depth inside the culvert does not meet WDFW recommended standards this culvert could not be unequivocally designated as ‘barrier’ or ‘non-barrier’ using the WDFW protocol. Consequently, barrier status was recorded as ‘unknown’ and further analysis is needed by WDFW staff to determine passage status (Appendix A, Photo Point P). A level B survey has been conducted on this culvert, however, level B analysis was not part of this survey. Level B culvert information is available upon request.

Map ID	Culvert ID	Sequencer	Passage Status (WDFW)	Passage Status (WT)	Photo #'s	Survey Date
P	FISH-04	1.1	UNK	33% Passable	36,37,38,39	3/23/2004
Location		Shape	Material	Span/Dia (ft)	Rise (ft)	Length (ft.)
Deep Meadow Lane		RND	CST	1.00	1.00	30.0
Culvert Slope (%)	Slope Break	Bed Material	Water Depth (ft)	Velocity (ft ³ /sec)	Outfall Drop	Plunge Pool Max. Depth (ft)
0.2	No	Yes	0.21	1.78	No	N/A
Plunge Pool Length x Width	Toe (ft)	Culv. / Toe Ratio (%)	Fill Depth (ft)	Ownership	Problem	
N/A	2.4	41.6	2.12	Private	Culv./Toe Ratio; Water Depth	
Comments:						
WDFW barrier status is unknown according to protocol; WT believes the culvert is 33% passable. Water depth inside the culvert does not meet the minimum state design recommendations of 0.8 ft for adult trout.

Photo Point P - Photo 36: Typical channel habitat downstream of the Fish-04 culvert.

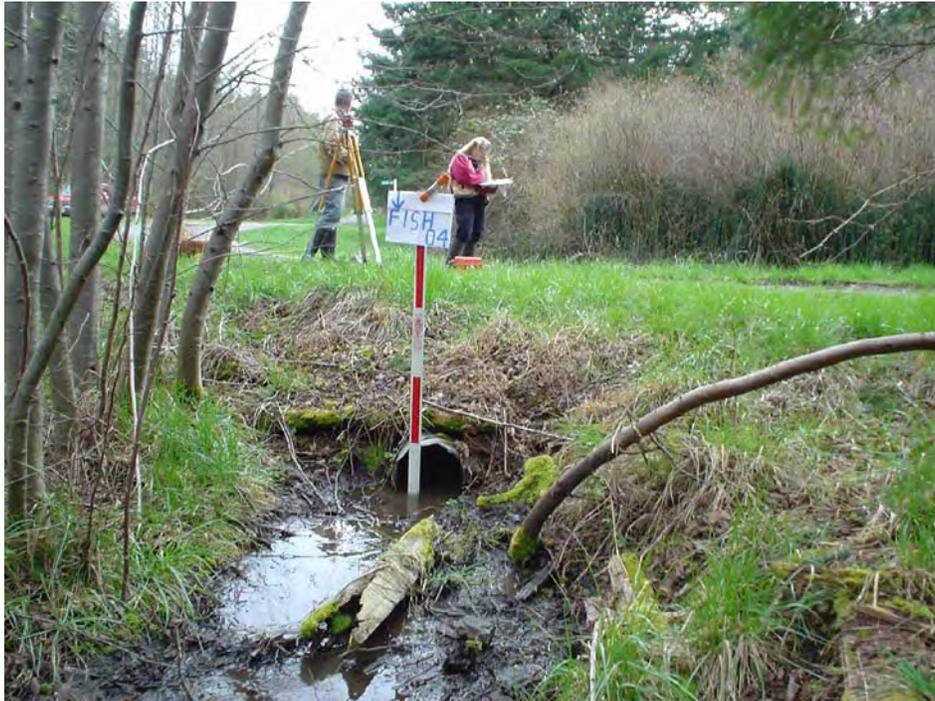
Photo Point P - Photo 37: Outlet of the Deep Meadow Lane culvert (Fish-04).

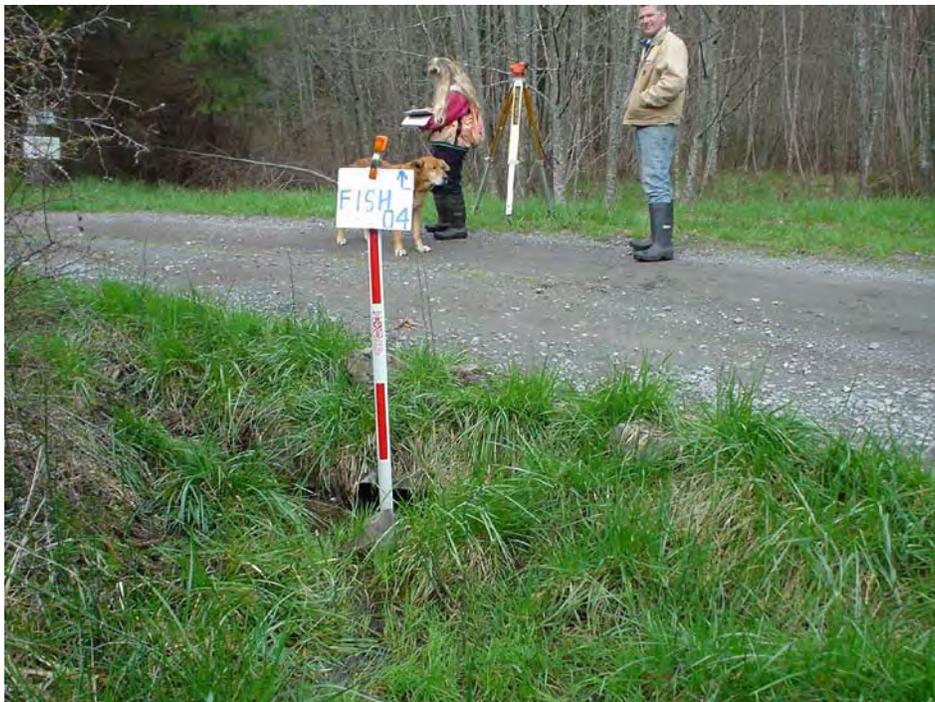
Photo Point P - Photo 38: Inlet of the Deep Meadow Lane culvert (Fish-04).

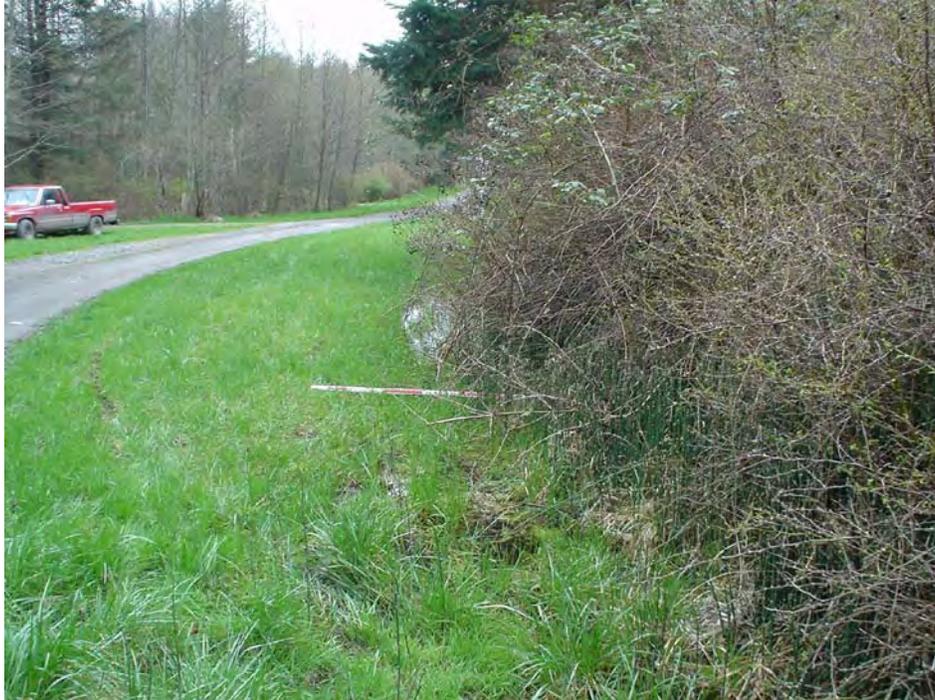
Photo Point P - Photo 39: Ditched channel which flows into the Deep Meadow Lane culvert (Fish-04).

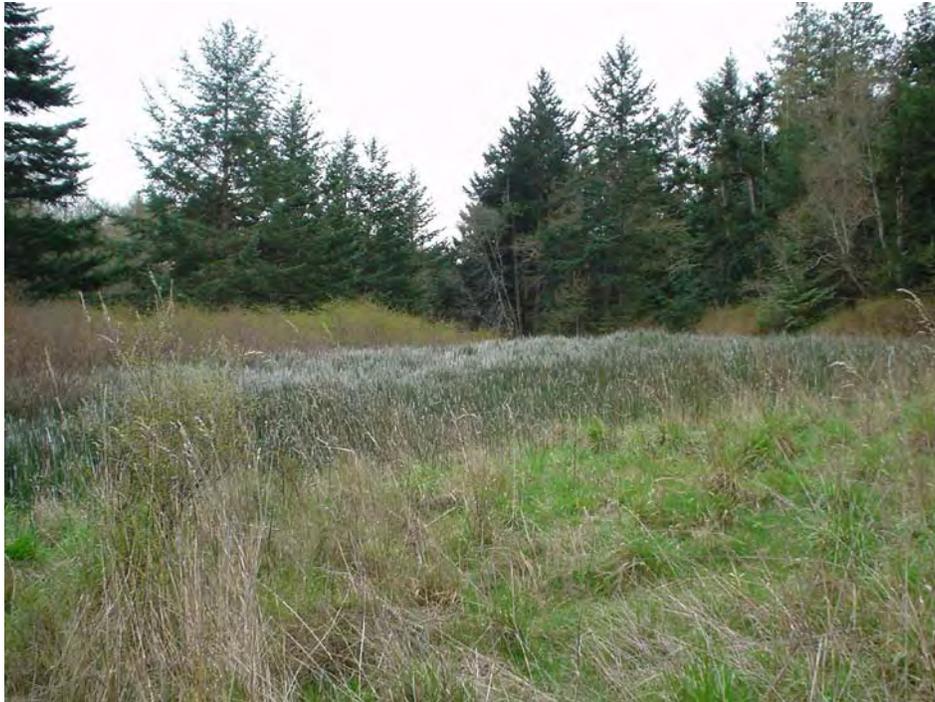
PHOTO POINT Q

Tributary. Consequently, although some of the stream flow remains in Treacy's Tributary substantial amounts of water are absorbed into the depositional soils and resulting wetland west of Deep Meadow Lane. As a result, fish passage upstream is thwarted by inadequate water depths.

Photo Point Q – Photo 40: Wetland and sediment deposition blocking Treacy's Tributary.

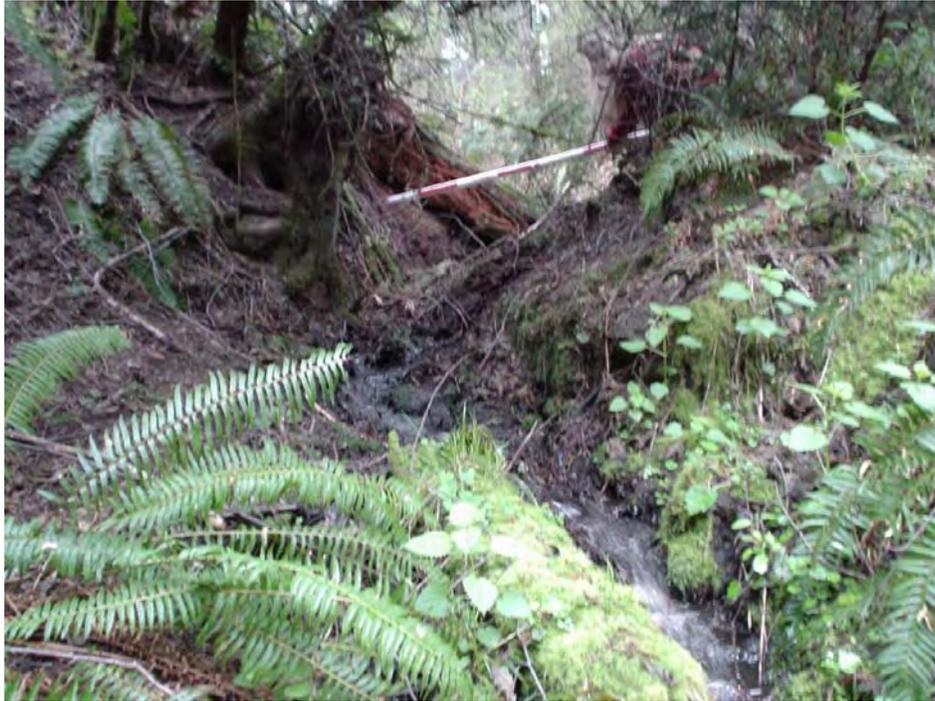
PHOTO POINT R

Photo Point R - Photo 41: High gradient chute on Treacy's Tributary. The chute has a gradient of 20% and extends for 21.0 ft.

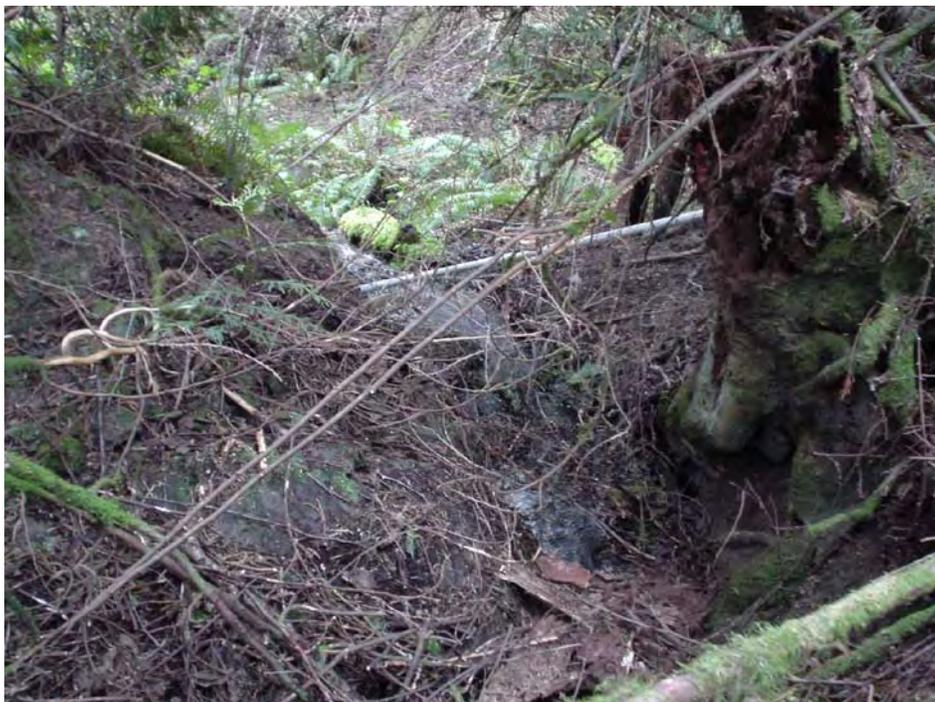
Photo Point R - Photo 42: Looking downstream at the high gradient chute described in Photo 41.
