Deer Harbor Estuary Habitat Restoration Project Orcas Island, Washington

Appendices to Environmental Assessment and Feasibility Study Report

**Prepared by:
Deer Harbor Restoration Project Team
Pursuant to IAC/ SRFB Grant No. 02-1577N
October 2005**

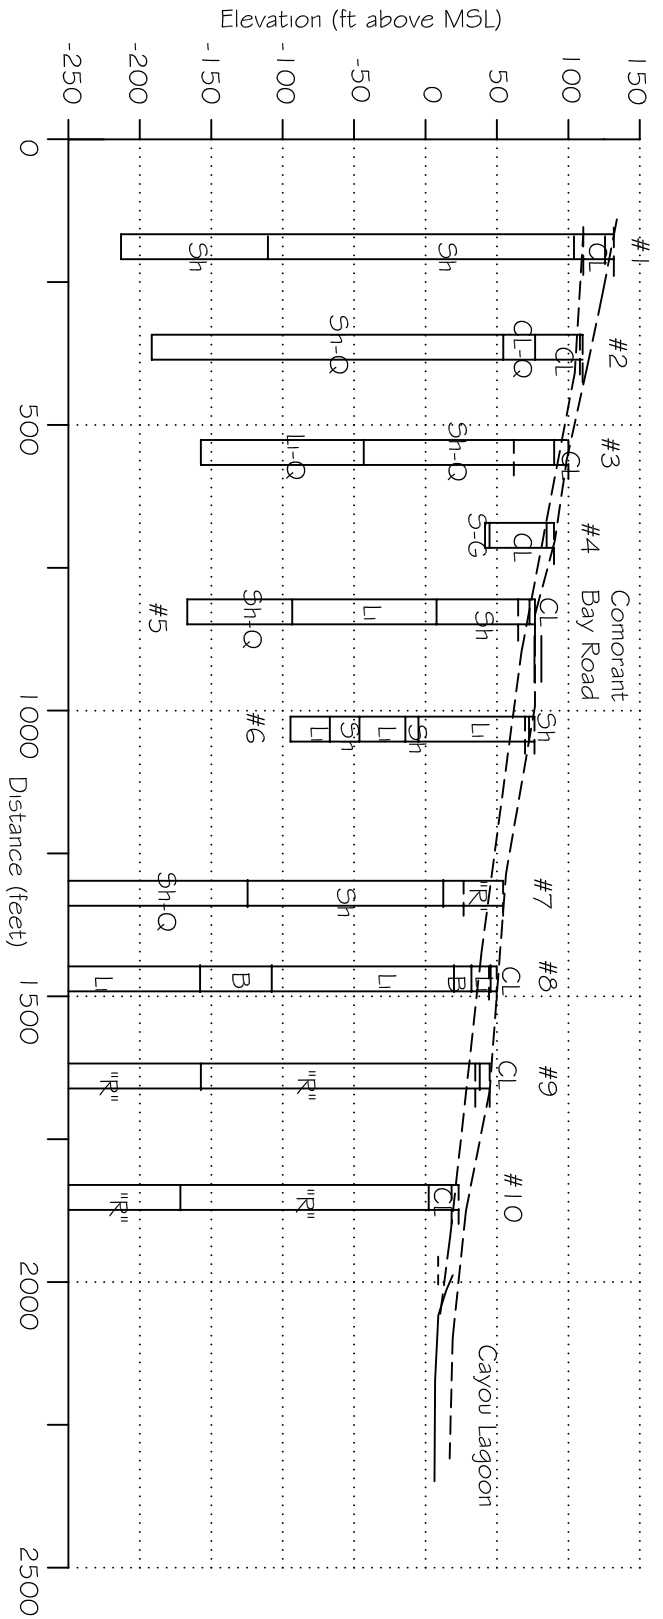
Well Logs in SW 1/4 Sec. 6: Comorant Bay Road South to Lagoon

- # = Identifying well log no.
- Cl = Clays (tan, blue)
- Sh = Shales (green, black)
- Q = Quartz inclusions
- L = Limestone
- B = Basalt
- "R" = unspecified rock
- = ground surface and static water level

Note: rock types and elevations are as reported in drilling logs

Geologic strata and elevations were summarized from drilling logs available on the Wash. Dept. of Ecology website. SJCCD does not warrant the accuracy of the data. Locations of wells are approximate and are intended for illustration purposes only.

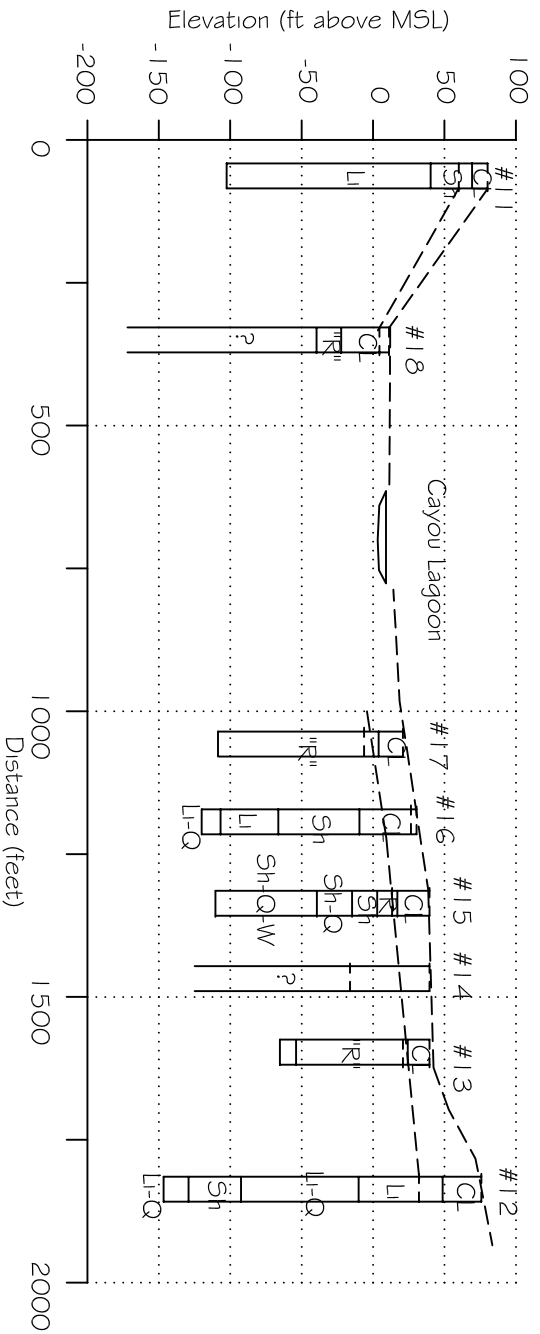
Well Logs in NW 1/4 Sec. 7: Cross Section West to East near Mouth of Lagoon
